WOOD DESTROYING PESTS AND ORGANISMS INSPECTION REPORT

Building No.	Street	City	Zip	Date of Inspection	Number of Pages
1625	Susquehanna Avenue	Placentia	92870	10/20/2016	Page 1 of 3

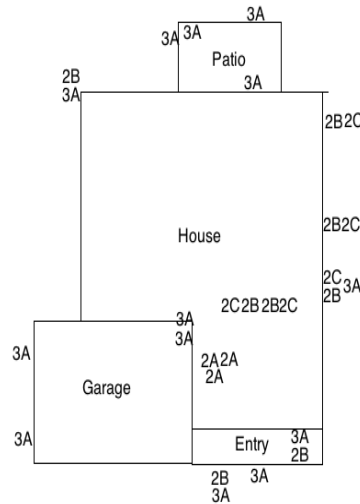
Key: 1 = Subterranean Termites 2 = Drywood Termites 3 = Fungus/Dryrot 4 = Other Findings 5 = Further Inspection DRAWING NOT TO SCALE

Item	Finding	Recommendation
2A	Evidence of Drywood Termites noted at Attics Area Section I	Microwave in visible and accessible areas as a primary method for the control of Drywood Termites. Cover or remove evidence of infestation(s). Note: The Microwave method is considered a localized treatment and is effective for the eradication of infestations in the areas that are specified for treatment. Chemical to be used: (None)
2B	Evidence of Drywood Termites noted at Exterior Area Section I	Microwave in visible and accessible areas as a primary method for the control of Drywood Termites. Cover or remove evidence of infestation(s). Note: The Microwave method is considered a localized treatment and is effective for the eradication of infestations in the areas that are specified for treatment. Chemical to be used: (None)
2C	Evidence of Drywood Termite damage @ Exterior Area Section I	Owner to employ licensed contractor to remove and replace damage or call for estimate. Chemical to be used: (None)

3A	Fungus damage and/or dryrot noted at Exterior Area Section I	Owner to employ licensed contractor to remove and replace Fungus damage or call for estimate. Chemical to be used: (None)
